Manhole Inspection Summary

Manhole # S61CC_018MH

Insp Date: **6/2/08 12:36 PM**

Location Address: **5410 Pulaski HWY**

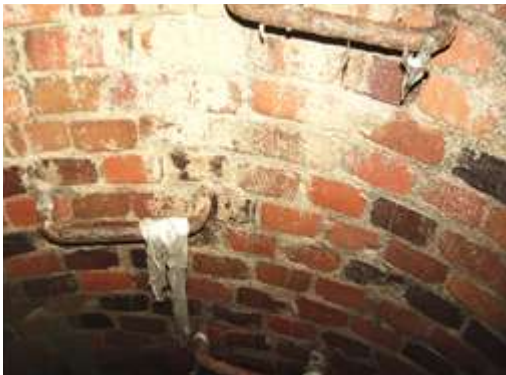
Defect 3

☒ **Evidence Of Surcharge** Depth: **3** (ft.) ☐ Active Surcharge Present

evidence of surcharge

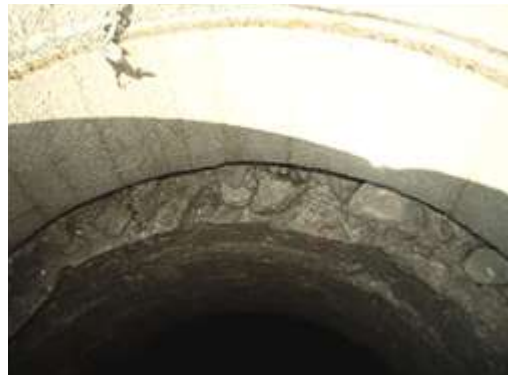
Defect 2

Offset: **2** (in.)

offset

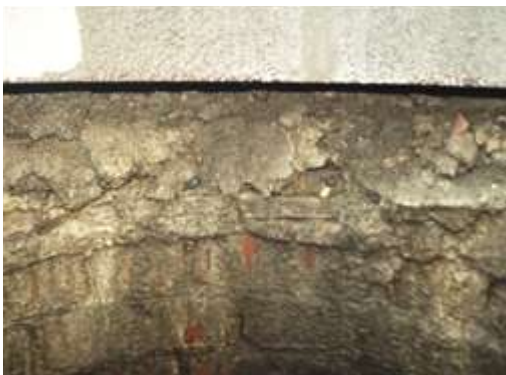
Defect 1

☒ **Leaks**

frame leaks

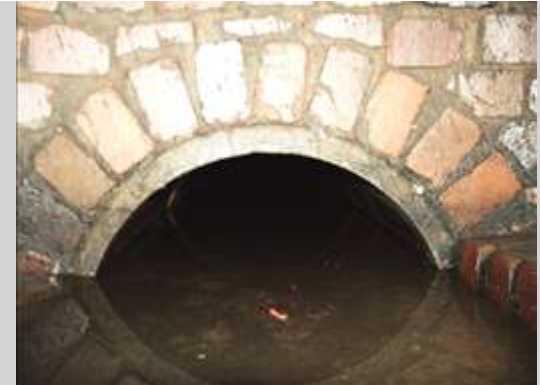
12 O'Clock Outflow

Pipe Height: **21.6** (in.) Rod and Bar (Angled)
Pipe Material: **Clay** ☐ Pipe Lined
Invert Depth: **11.83** (ft.) Flow Characteristics: **Slow**
Deposits: ☐ None ☒ **Mud** ☐ Sludge ☒ **Debris** ☐ Grease
Silt Depth: **12** (in.) Deposits Extent: **Medium**
Infiltration: **None** Pipe Seal Cond: **Sound**

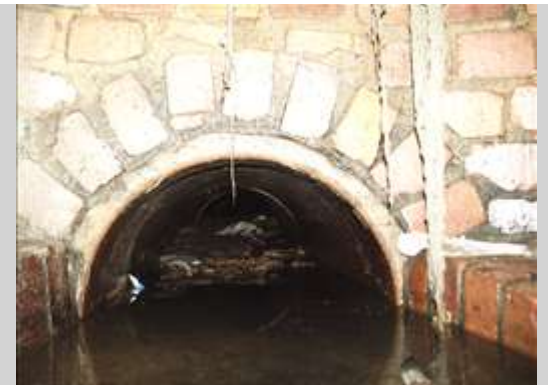
6 O'Clock Inflow

Pipe Height: **19.2** (in.) Rod and Bar (Angled)
Pipe Material: **Clay** ☐ Pipe Lined
Invert Depth: **11.33** (ft.) Flow Characteristics: **Slow**
Deposits: ☐ None ☒ **Mud** ☐ Sludge ☒ **Debris** ☐ Grease
Silt Depth: **8** (in.) Deposits Extent: **Heavy**
Infiltration: **None** Pipe Seal Cond: **Sound**

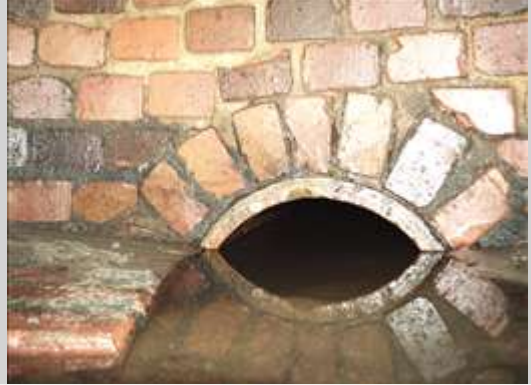
9 O'Clock Inflow

Deposits: ☐ None ☒ **Mud** ☐ Sludge ☒ **Debris** ☐ Grease

Silt Depth: **5** (in.) Deposits Extent: **Heavy**
